TECH BULLETIN # 3

MODEL - 924S,944/S/T

SUBJECT - OIL COOLER AND OIL PRESSURE RELIEF VALVE

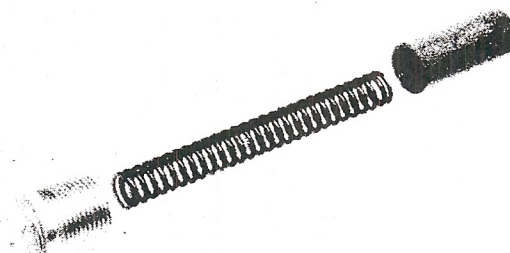
Figure 1

From start of production 1983, 944 cars came equipped with a spring and piston oil pressure relief valve (figure 1). This was used in all 944 and 944 Turbo up to the end of 1986 production. Also early 1987 924S used this system. In 1987 production of 944, 944S and 944 Turbo, a new type one-piece oil pressure relief valve PN 944 107 035 01 was installed (figure 2). Later production 1987 924S also received this valve. At around the same time a new type one-piece pressure relief valve, PN 944 107 035 11 was introduced as a retrofit to repair earlier engines from 1983 to 1986 along with the early 924S. With this, the old type spring and piston was discontinued as a spare part.

**Up to and including 1986 Model Year
original equipment.
Three piece oil pressure relief valve.**

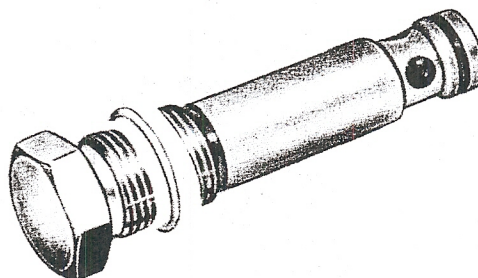
Figure 2

**From July 1986 (1987 Model year).
One piece oil pressure relief valve.**

When repairs are made to engines which fall between the above mentioned engine numbers, the oil pressure relief valve must be replaced with pressure relief valve PN 944 107 035 01.

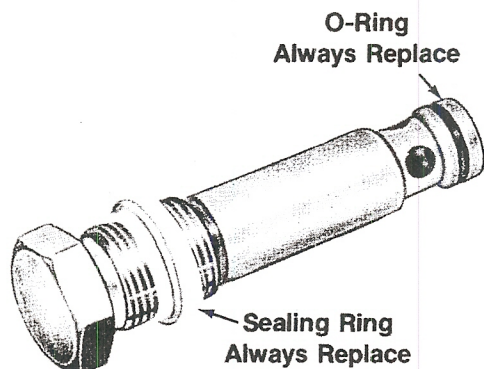
If the pressure relief valve is removed, always replace the aluminum sealing ring, PN N 043 815 3 and install a new O-ring.

For valve PN 944 107 035 11 use O-ring PN 944 107 935 11.

For valve PN 944 107 035 01 use O-ring PN 944 107 935 01.

Coat the relief valve O-ring and outer surface with oil to prevent binding during installation.

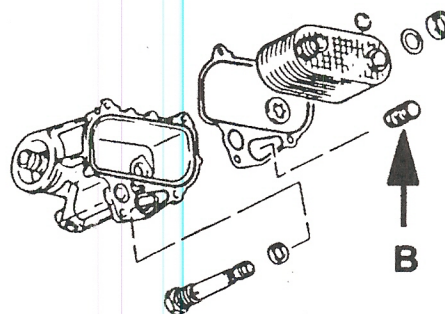
NOTE: Special tool 9215 is only used in engines having a steel sleeve installed in the oil pressure relief valve passage (1983-1986). It is important that the sleeve (arrow B below) be firmly installed in the crankcase. If loose, the oil cooler housing must be removed and the sleeve secured with loctite 648 or 638. Drive the sleeve to stop with special tool 9215. Consult the 944 Workshop Manual Vol. I, page 17-22 for additional instruction.

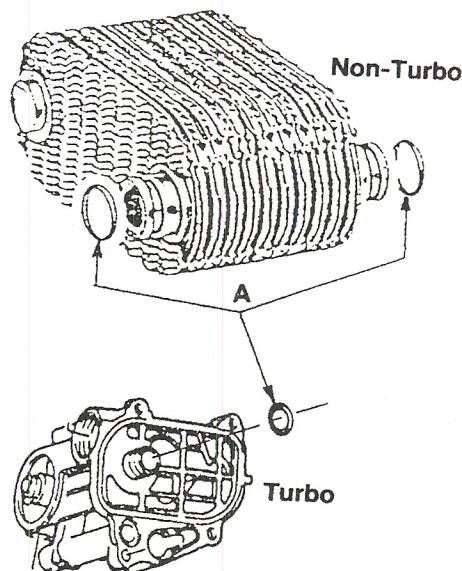
Figure 1

A - original design
B - new design

The sealing O-rings (A, figure 1) located on the oil cooler of normally aspirated cars and on the connecting pipe of the oil thermostat housing of Turbo cars, have been changed. The new version O-ring is now green in color (formerly red). When repairing, use ONLY the new version green O-rings PN 999 707 043 40.

Please note that the O-ring "A" in Fig. 1, is also installed in 944 Turbo cars. There are two O-rings on a short connecting pipe in the same place as they are found on normally aspirated cars.

To determine if the oil cooler housing is the latest version, and to help prevent needless housing replacement, inspect as shown.

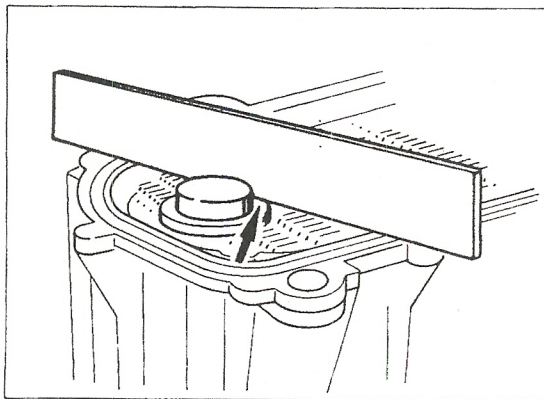
Install new version O-rings onto oil cooler. Install plastic washer onto cooler guide boss (use light grease to hold washer in place if necessary). Lubricate cooler O-rings with oil to prevent rolling and insert cooler into housing. Use straightedge on housing and determine distance between oil cooler guide boss and straightedge (see photo below). With shims installed, measurement should be $0 \pm 0.25\text{mm}$. The oil cooler housing gasket is **NOT** included in the measurement. Thickness of one shim is 0.5mm.

Before installing cooler assembly, mount a new rubber ring (arrow 4) onto crankcase and hold in place with light grease or Curil.
